**Energy Efficiency Evaluation Report  
City of Whitefish Emergency Services Center  
275 Flathead Ave  
Whitefish, MT 59337**

Prepared and provided by  
**Montana Resource Efficiency Program (MREP)**

Nov 8, 2017

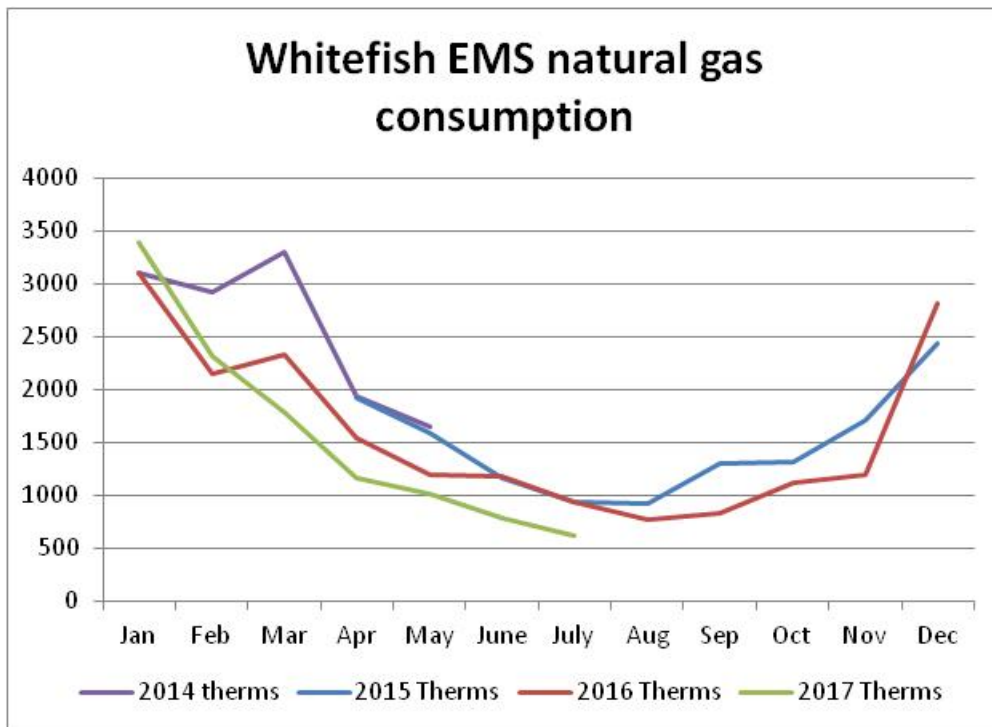
**Figure 1. Monthly Natural Gas Consumption**

This natural gas energy use profile is typical for a building that uses natural gas for heating and domestic hot water. The summer gas usage is higher than expected because of year-round heating needs in the courtroom and associated spaces. Summer heating gas consumption was estimated by calculating the heat loss from piping throughout the building plus a small increase for the actual heat produced and boiler cycling losses. The domestic hot water consumption was calculated based on the summer monthly gas consumption minus the calculated heating usage and applied to all 12 months. The balance of the total natural gas consumption is assumed to be used for heating.

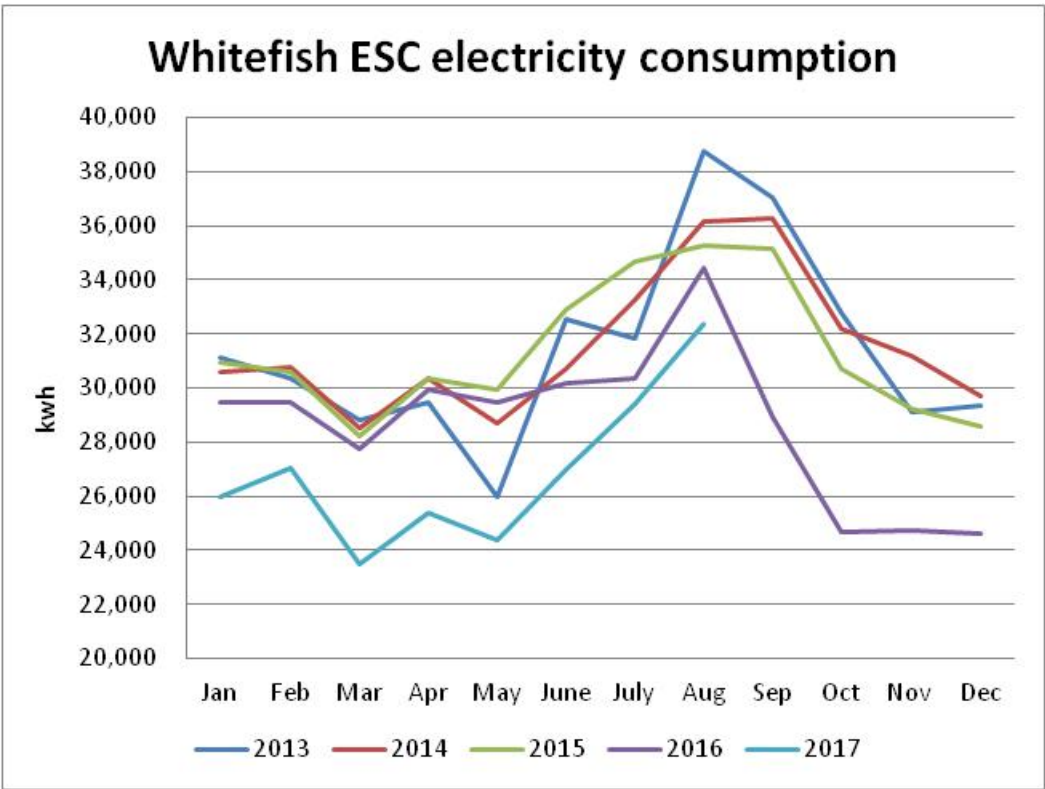
**Figure 3. Monthly Electricity Consumption**

This electrical energy use profile is representative of an air-conditioned building in this climate since the consumption rises in the summer and drops in the winter. Analyzing the electricity use by the different equipment within the facility assists the analyst and building owner in assessing and quantifying different energy conservation recommendations. Lighting electricity consumption is based on a lighting audit. Typically, cooling consumption is the difference between the daily summer and winter consumption, and miscellaneous/plug loads are the balance. However, in this case, this method did not provide accurate results, estimating only 5% of the annual energy consumption being cooling and 74% being miscellaneous/plug loads. As a result, this audit only breaks out the energy consumption of the lighting.

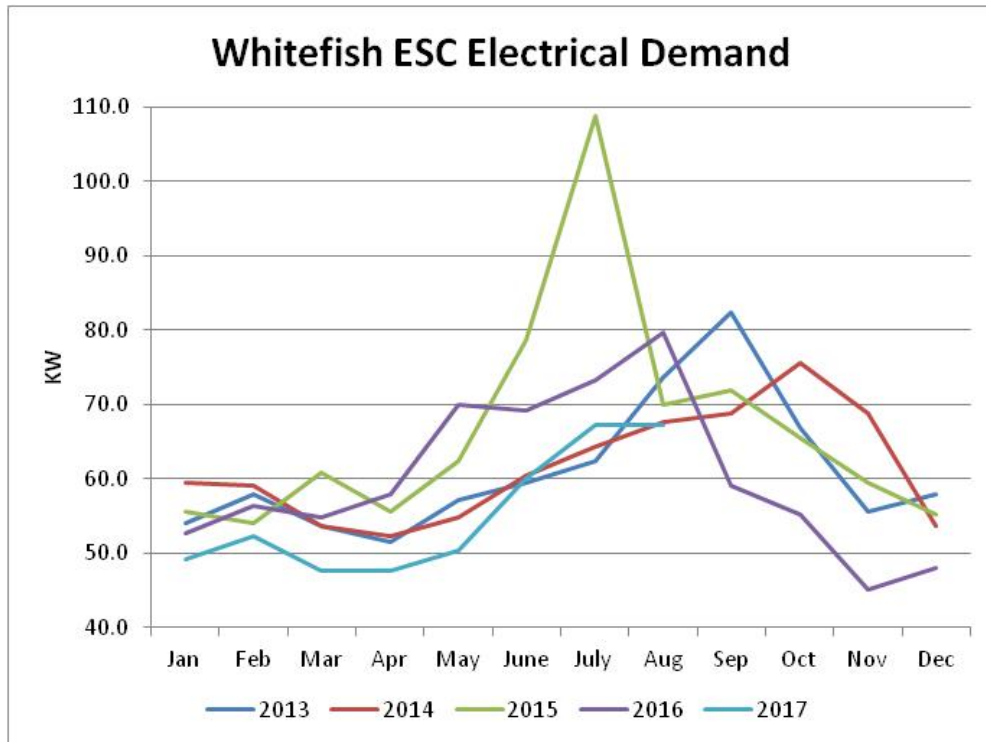
**Figure 5. Monthly Electricity Demand**

As shown in Figure 5, the monthly demand profile does show one anomaly which occurred in July 2015. Monthly demand charges should be monitored closely as they can significantly raise the electrical charges. High demand readings can be caused by changes in operation or meter

read errors. Other than this one reading, the monthly demand is representative of an air-conditioned building.

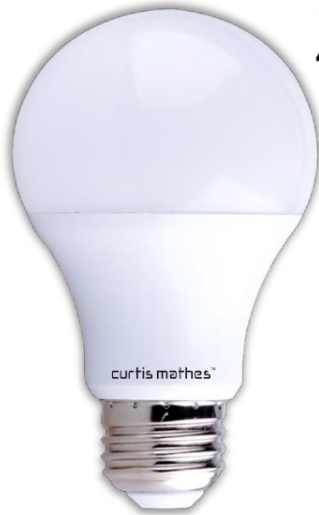
# A19 Omni-Directional LED Light Bulbs

## 40W & 60W Incandescent Replacement

- 9W LED A19 bulb equals 60W incandescent bulb, deliver 800lm brightness
- 6W LED A19 bulb equals to 40W incandescent bulb delivering 470lm
- Omni-direction diffusing light beam at average 300°
- Instant on-No warm-up period
- No UV/IR light in the beam
- Available in 2700K and 4000K Color Temperature
- Excellent Color Rendering at >80
- 25,000 hours rated life, it will last 22.8 years based on 3 hours per day usage
- Limited 10 year replacement warranty
- Dimmable & compatible with major dimmer brands

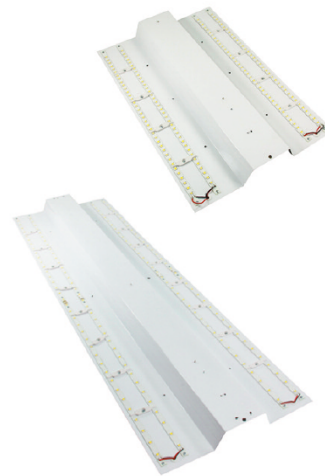
- Galvanized and painted 22 ga. body for maximum life and reflectance
- Insulated LED board mounting clips
- Insulated mounting grommets
- Integrated tunnel cover houses driver
- VHB adhesive holds LED strips in contact with body for thermal efficiency
- 'S' hook for temporary hanging in installation
